**DEPARTMENT OF TRANSPORTATION****DIVISION OF ENGINEERING SERVICES**

Contract #: 04-0120F4Cty: SF/ALA Rte: 80 PM: 13.2/13.9File #: 99.28**WELDING INSPECTION REPORT****Resident Engineer:**Siegenthaler, Peter**Address:** 333 Burma Road**City:** Oakland, CA 94607**Report No:** WIR-024640**Date Inspected:** 13-Feb-2011**Project Name:** SAS Superstructure**OSM Arrival Time:** 1500**Prime Contractor:** American Bridge/Fluor Enterprises, a JV**OSM Departure Time:** 300**Contractor:** Zhenhua Port Machinery Company, Ltd (ZPMC) Changxing Island **Location:** Shanghai, China**CWI Name:** Sha Zhi**CWI Present:** Yes No**Inspected CWI report:** Yes No N/A**Rod Oven in Use:** Yes No N/A**Electrode to specification:** Yes No N/A**Weld Procedures Followed:** Yes No N/A**Qualified Welders:** Yes No N/A**Verified Joint Fit-up:** Yes No N/A**Approved Drawings:** Yes No N/A**Approved WPS:** Yes No N/A**Delayed / Cancelled:** Yes No N/A**Bridge No:** 34-0006**Component:** OBG**Summary of Items Observed:**

OBG Bay 14

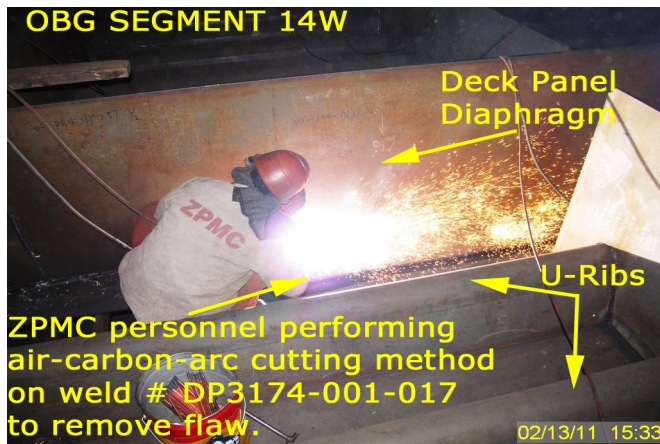
During random in process observations of OBG Segment 14W, this QA inspector observed ZPMC personnel performing air-carbon-arc cutting method to remove UT detected Flaw on a weld joint identified as DP3174-001-017 located on Deck Panel of the OBG Segment 14W. This QA performed Visual Testing (VT) of the joint and found they appeared to be in general compliance with the applicable contract documents. For more details please see photo below:
